Community Involvement in University Research

Hans Schreier, Land & Water Systems Program, UBC

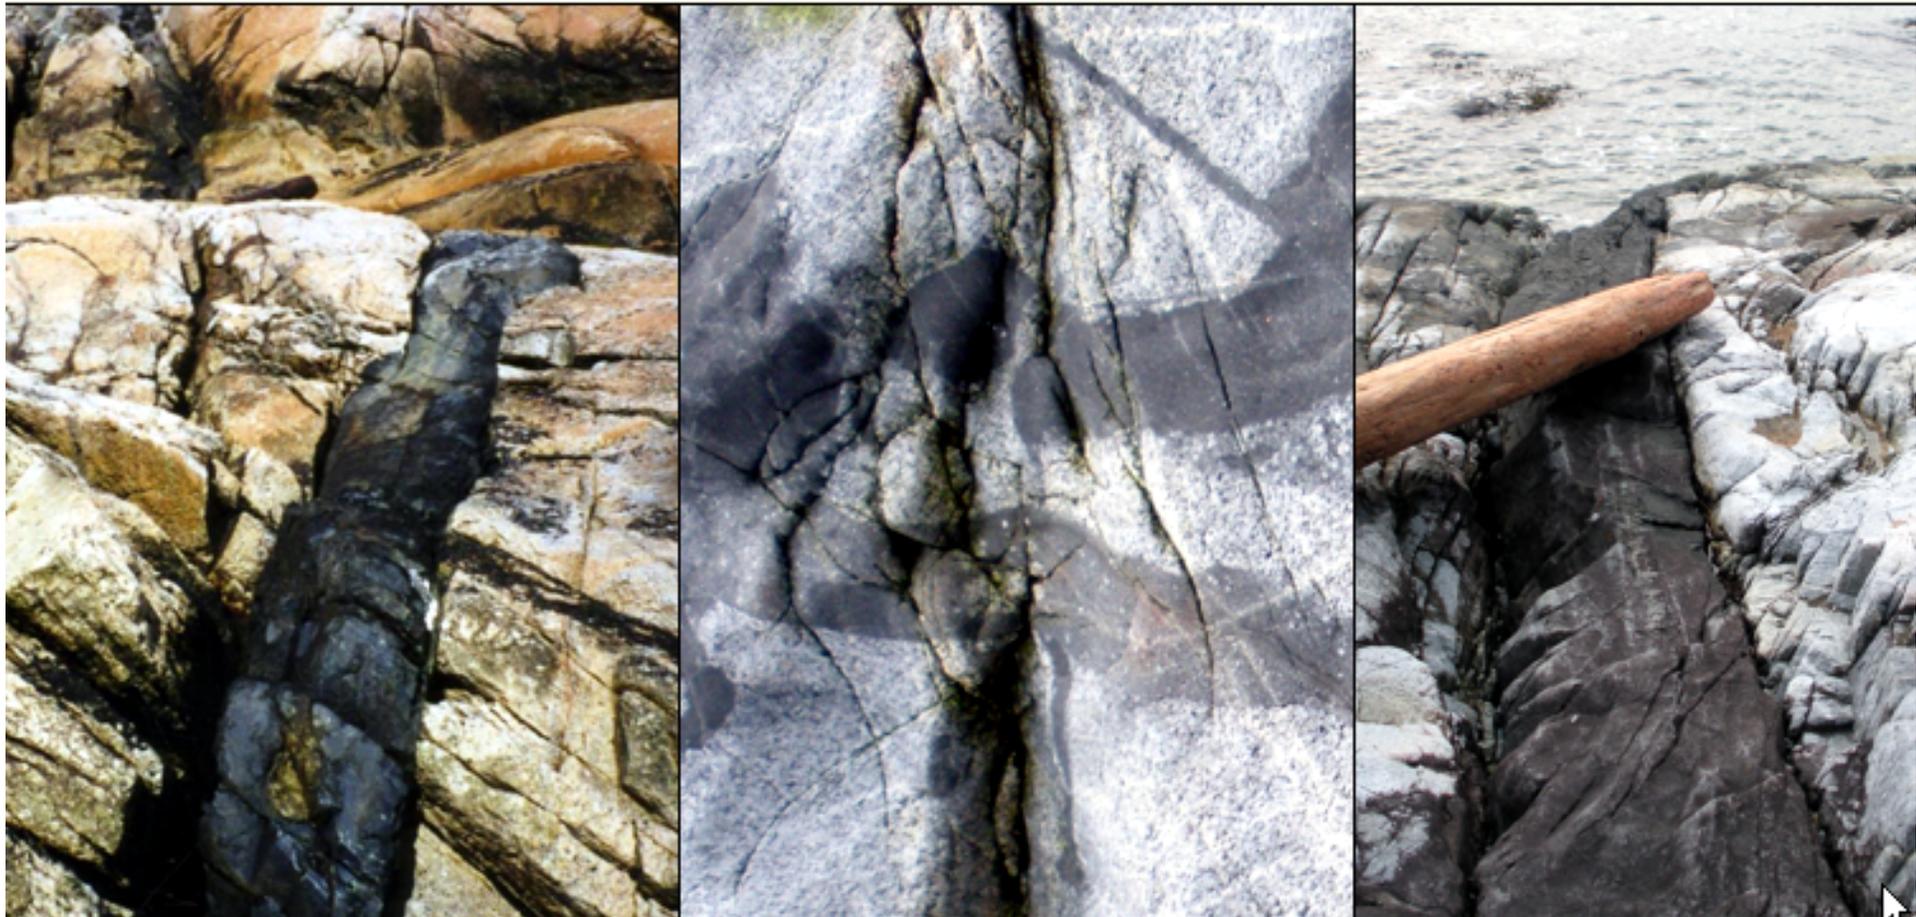
Likely Source of Arsenic: Volcanic Intrusions into Igneous Rocks

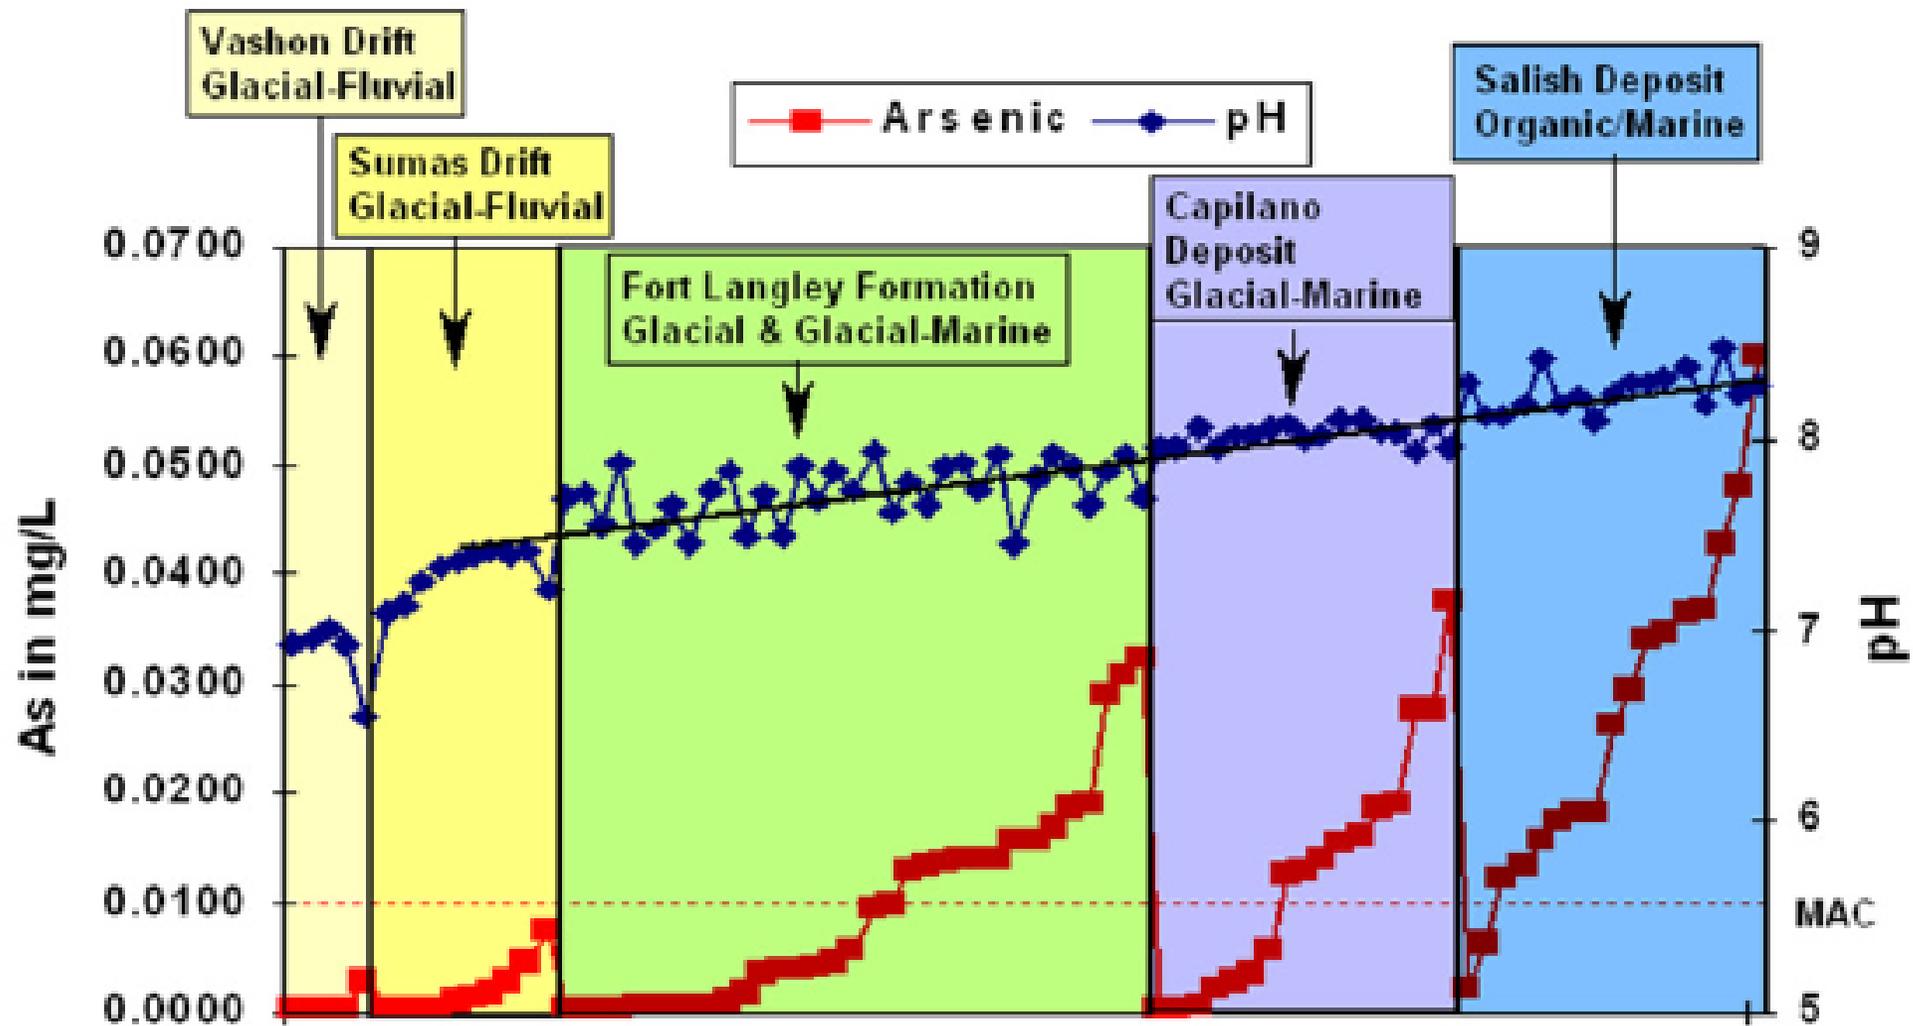
Samples sorted by Surficial Materials

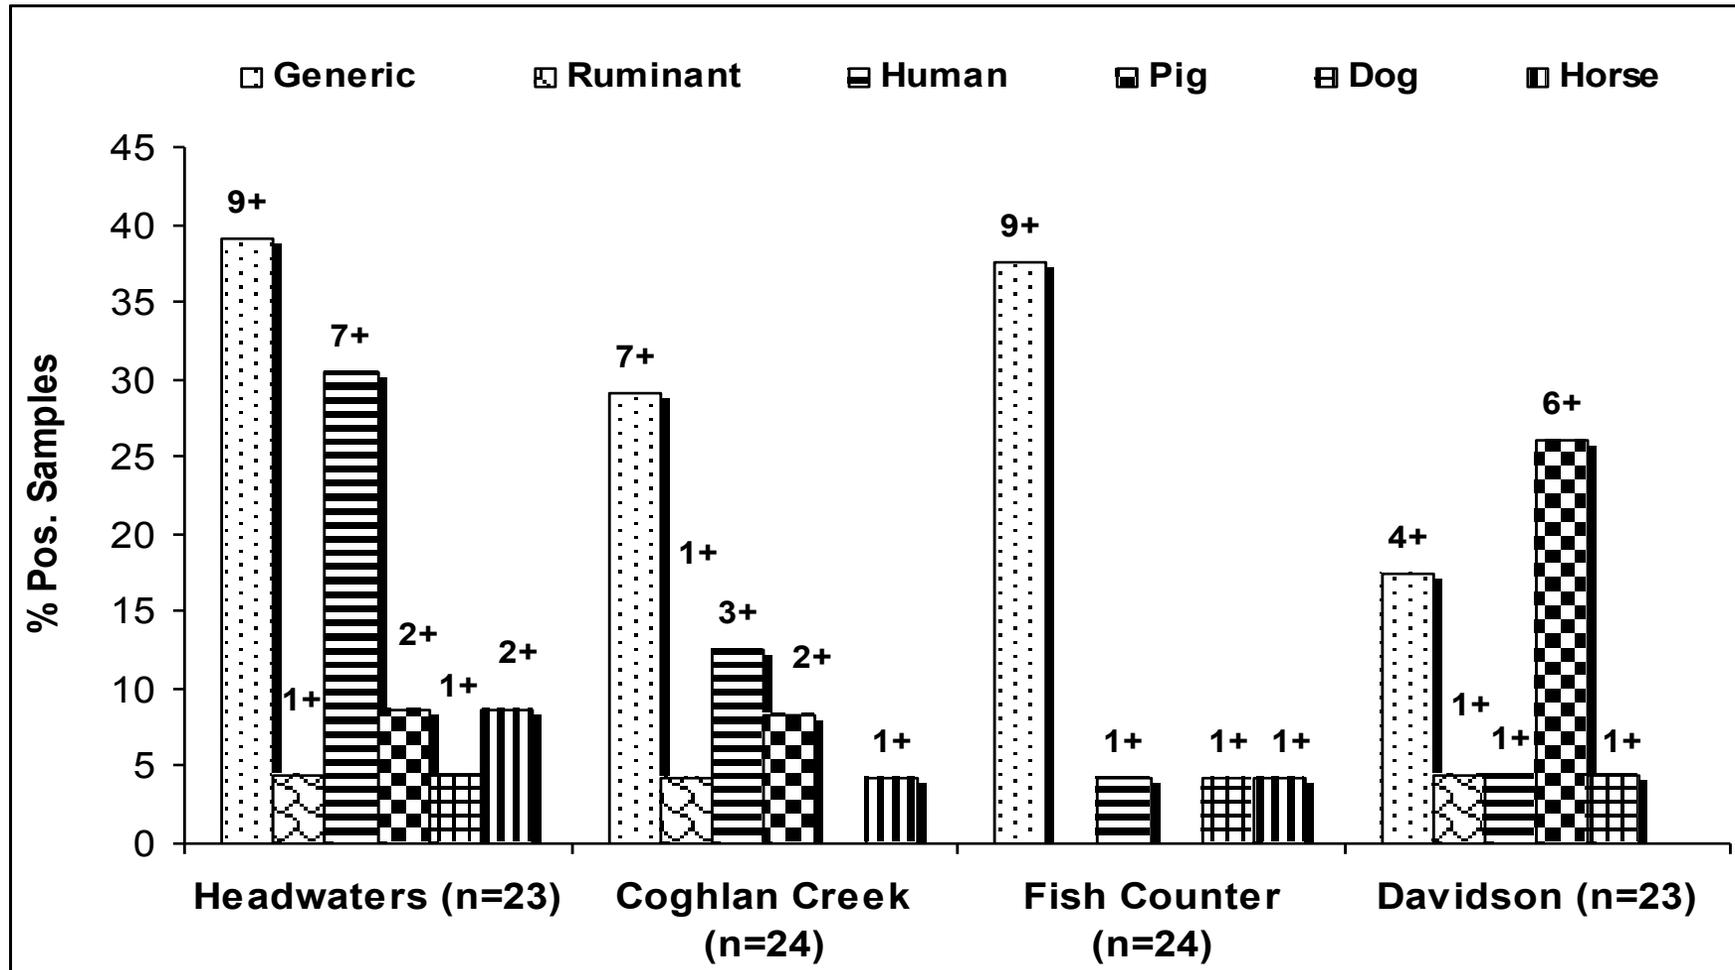
Generic Host Specific Bacteroides Markers In Water In different Parts of the Salmon Watershed

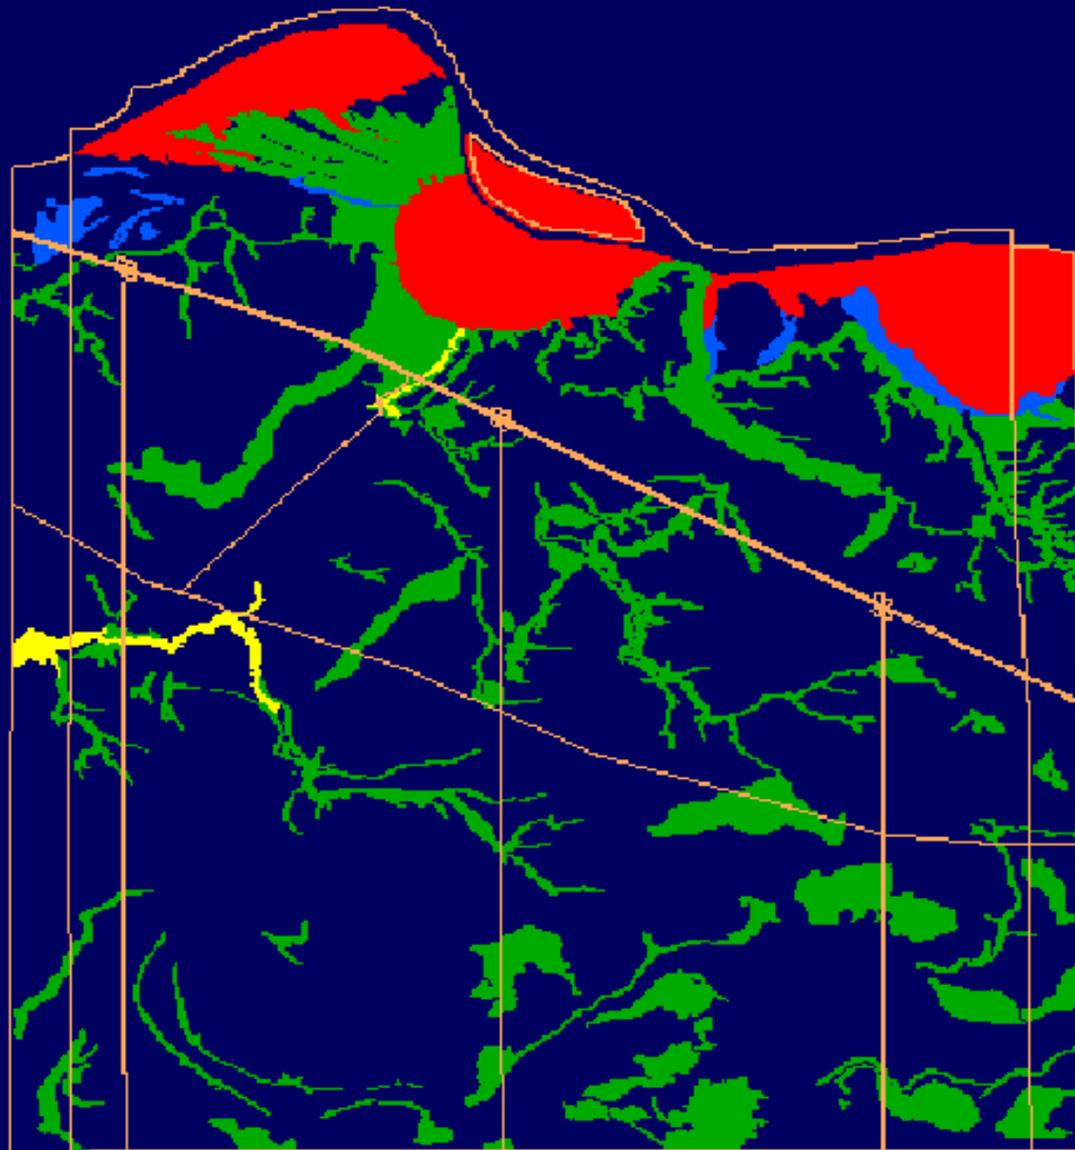
Geological sensitivity

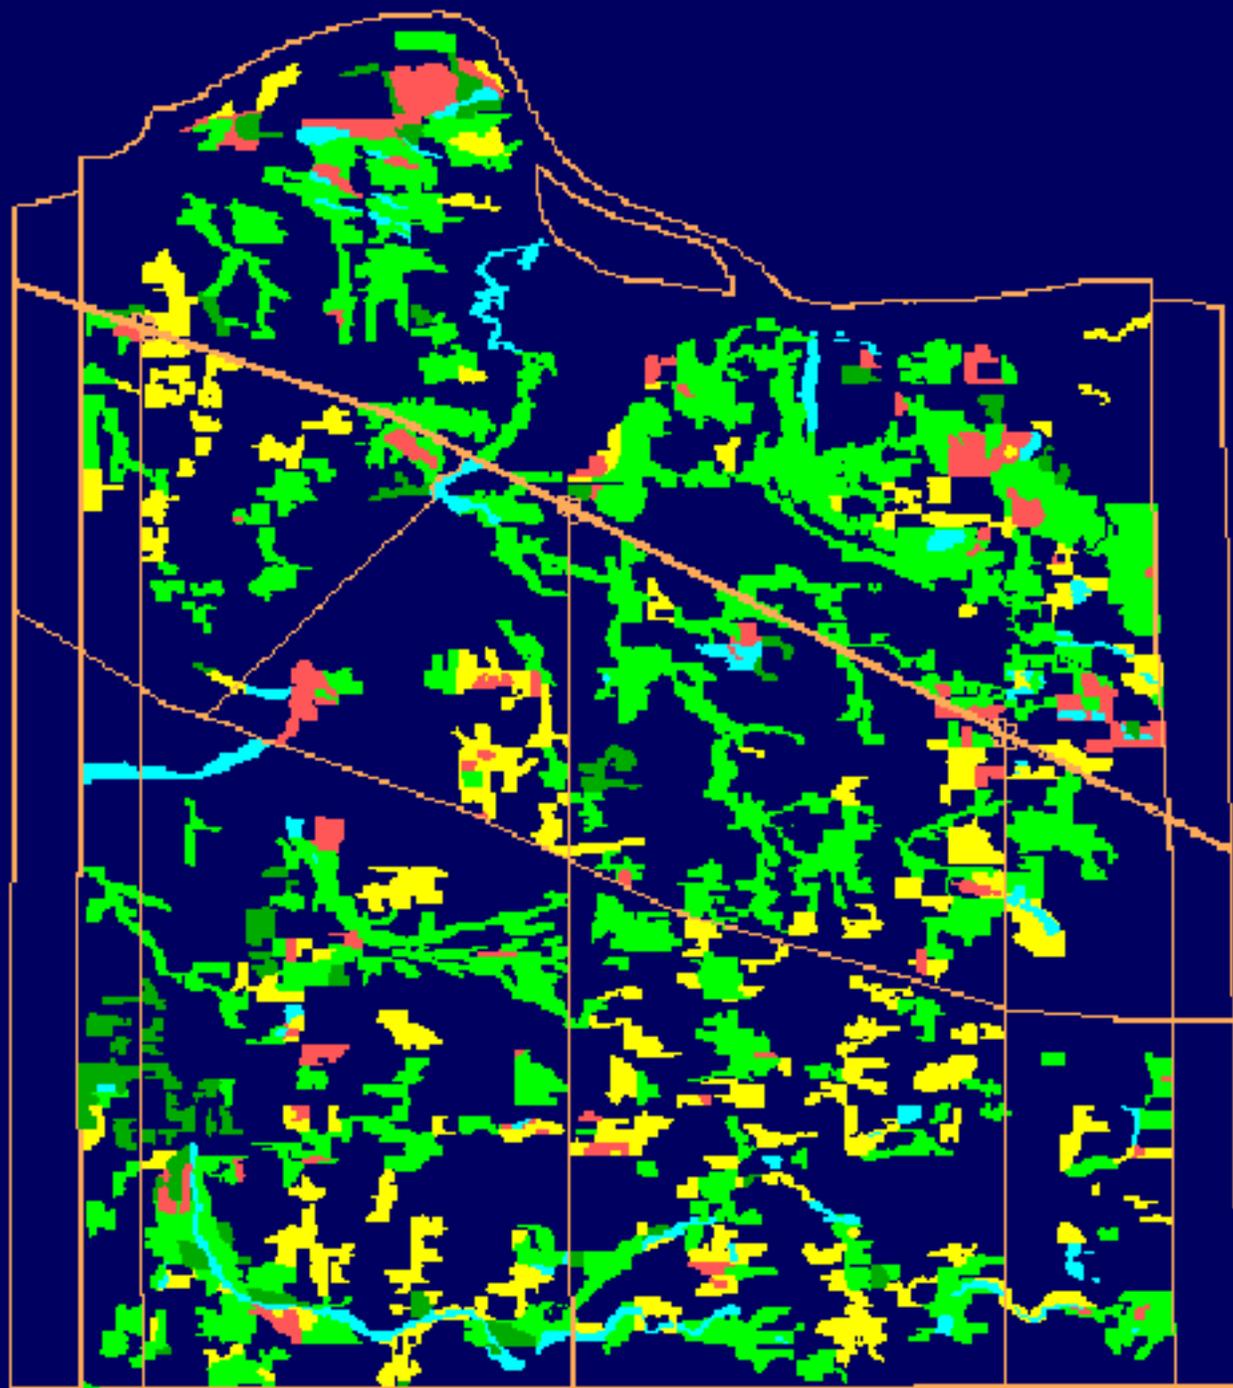
Potential Soil Erosion

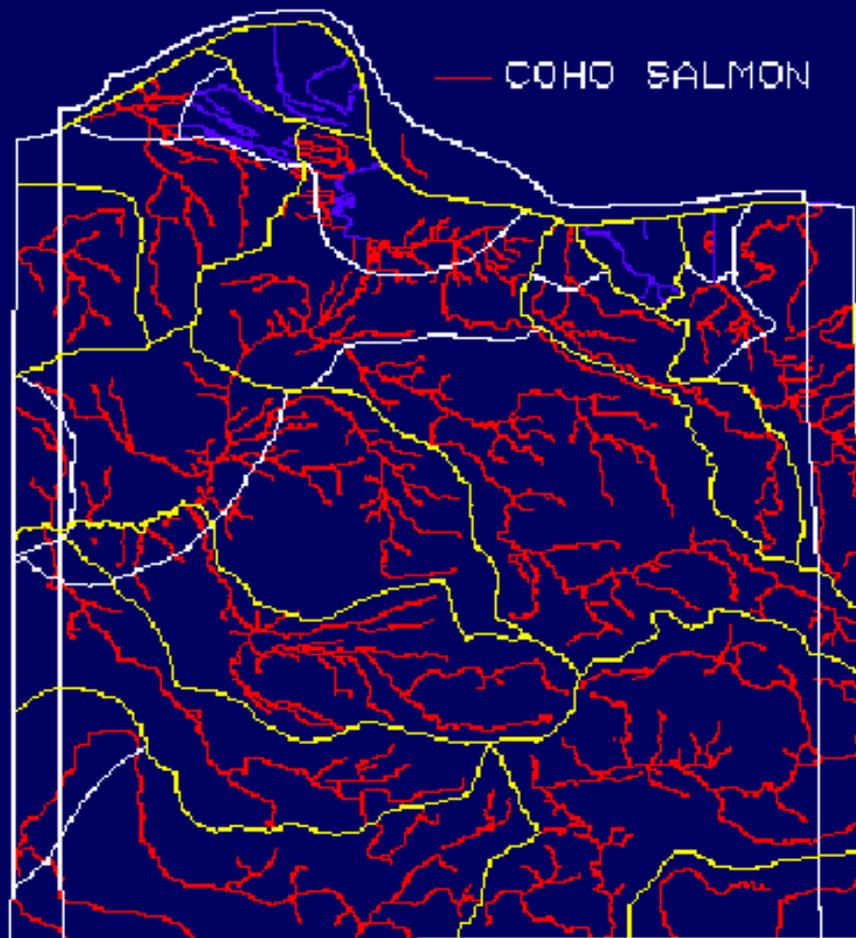
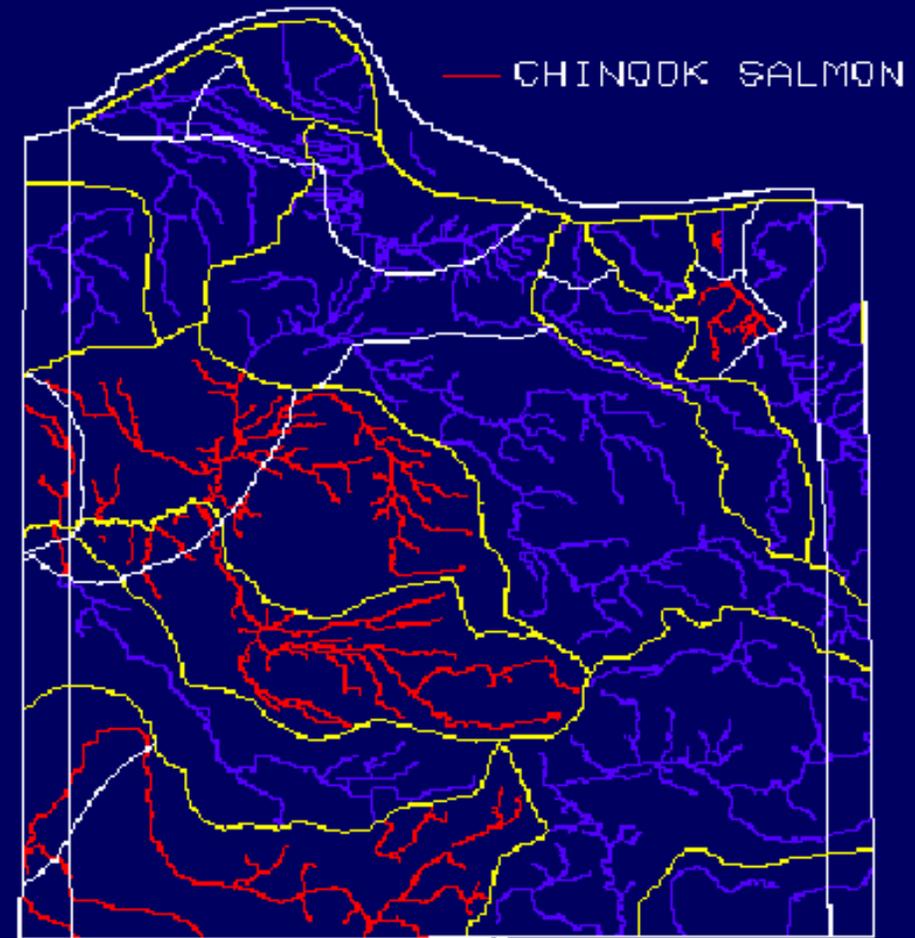
Fish distribution

- coho and chinook are 2 important salmonid species found in the Township
- gravel substrate, consistent stream flow supplied by groundwater and good instream cover (boulders, logs, cutbanks) provide excellent spawning and rearing opportunities

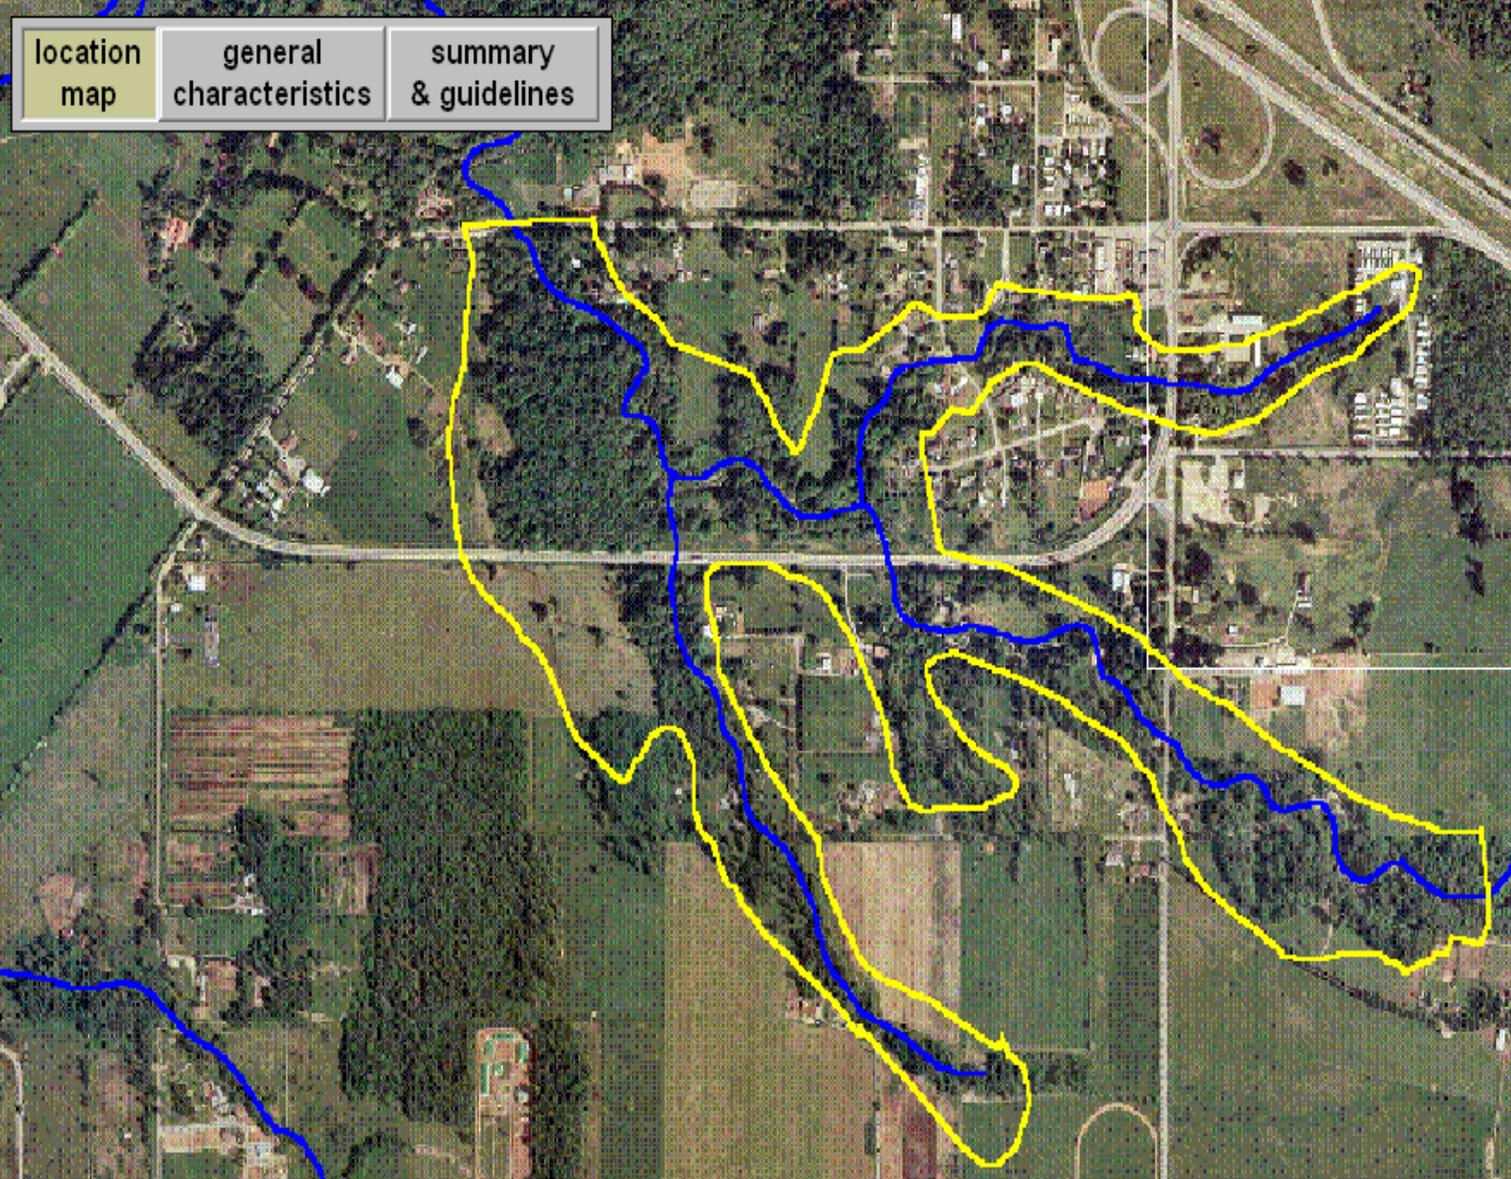
ESA 22: Salmon River Middle Reaches

General	ESA desig'n	ESA 1
	type	watercourse, forest
Abiotic	landform	dissected stream system
	surficial	marine
	groundwater	-
	slope	2 - 5% undulating to 30 - 60% hilly
	size	70.5 ha
Biotic	vegetation	mixed forest; riparian
	birds	birds of prey - high, songbirds - high
	fish	salmonids = 3, other = 2, total = 5 habitat for salmonid spawning and rearing
Cultural	land use	stream system
	visual zone	06 - Upland Rural Residential Zone 12 - Nickomekl Headwaters
Criteria fulfilled	fragility	permanent watercourse
	fragility	erosion along watercourse

Summary	<p>The middle reaches of the Salmon River include the mainstem and associated tributaries from 72 Avenue to approximately 236 St, flows over marine deposits and the vegetation adjacent to the river is primarily mixed forest. The diversity of songbirds and birds of prey is estimated to be very high. The land use surrounding this section is mostly agriculture with some rural residences. The river provides excellent spawning and rearing habitat for salmonids. A few non-salmonid fishes reside in mainstem and tributaries.</p>	
Management guidelines	watercourse	maintain a leavestrip of natural vegetation (30 m in high density urban, otherwise 100 m) from the top of the slope break of a permanent watercourse
		maintain a leavestrip of natural vegetation on either side of the intermittent watercourses
		restrict access by livestock to watercourse to prevent nutrient additions, disturbance of bank and vegetation and siltation of the watercourse

fish habitat	restrict residential development adjacent to watercourse to protect high value salmonid spawning/rearing habitat
protect riparian habitat (i.e. streamside vegetation)		
		remove or reduce the detrimental effects of barriers to fish migration (i.e culverts, pumping station)

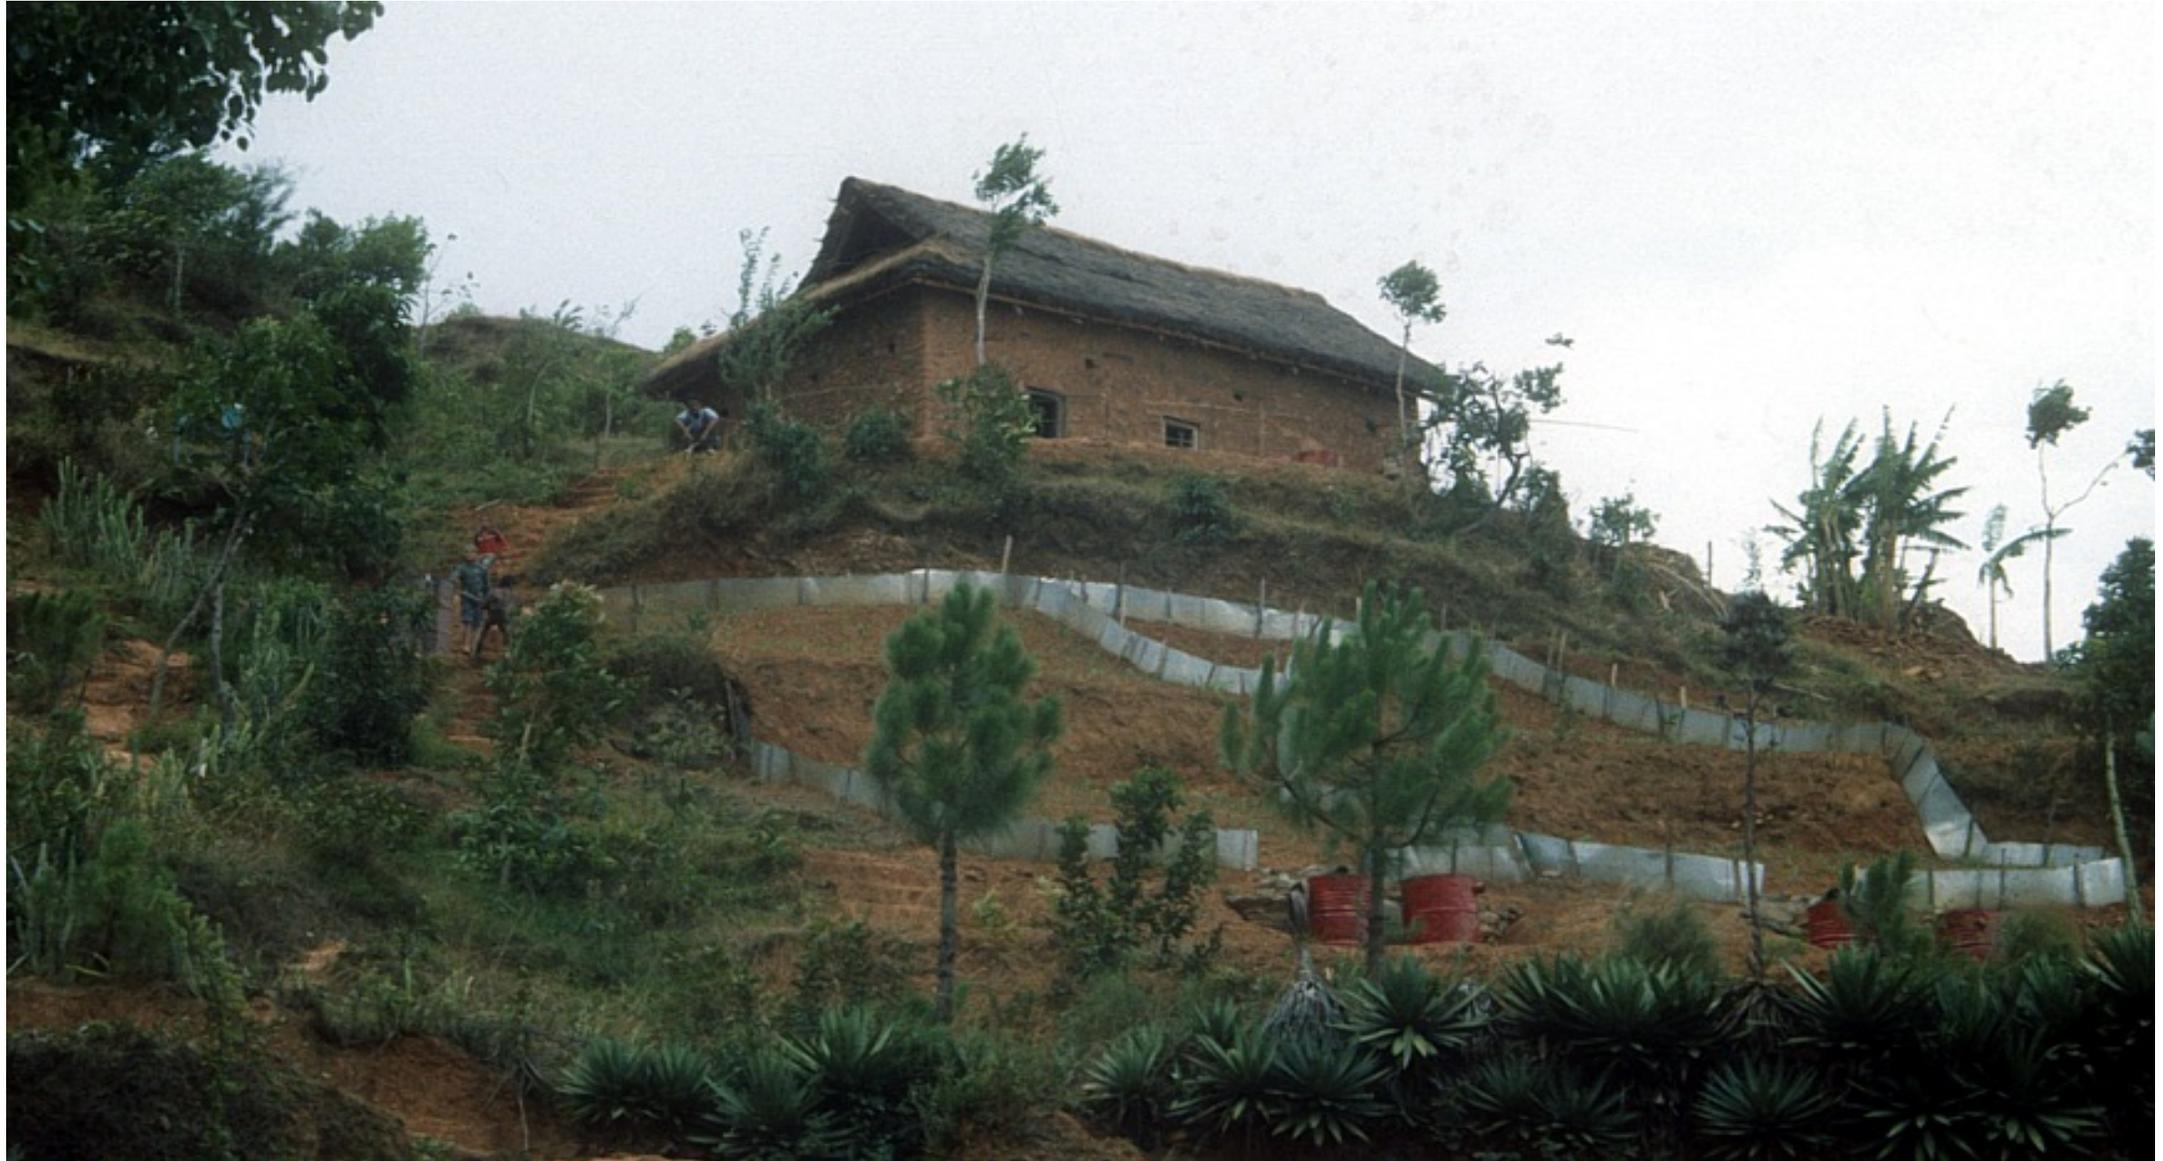
On Farm Erosion Plot Study over 10 Years
