# Upper Columbia Swallow Habitat Enhancement Project

2021-2025 Final Report

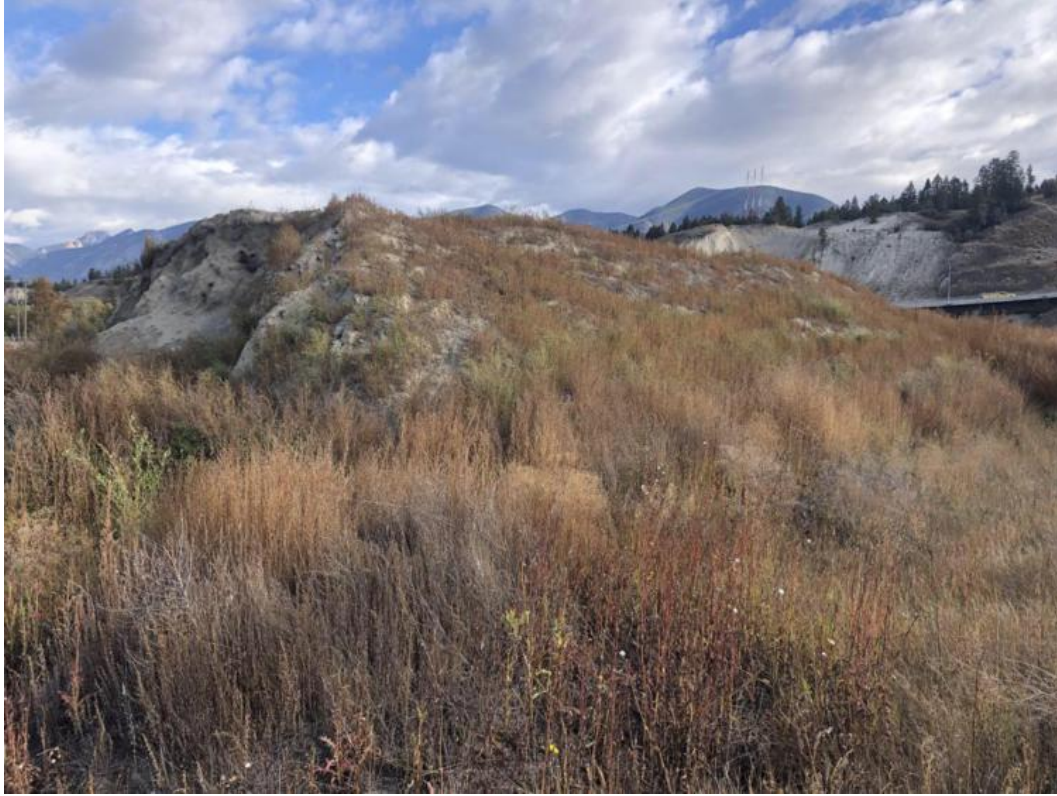
Additional measures were implemented to protect and maintain existing Bank Swallow colonies, recognizing that habitat degradation and disturbance are key limiting factors. Vegetation removal was conducted at a colony site in the Blaeberry to maintain open flight paths and preserve visibility of nesting faces. Encroaching shrubs and small trees were selectively removed to reduce obstruction, improve access to nesting areas, and reduce potential predator perching opportunities.

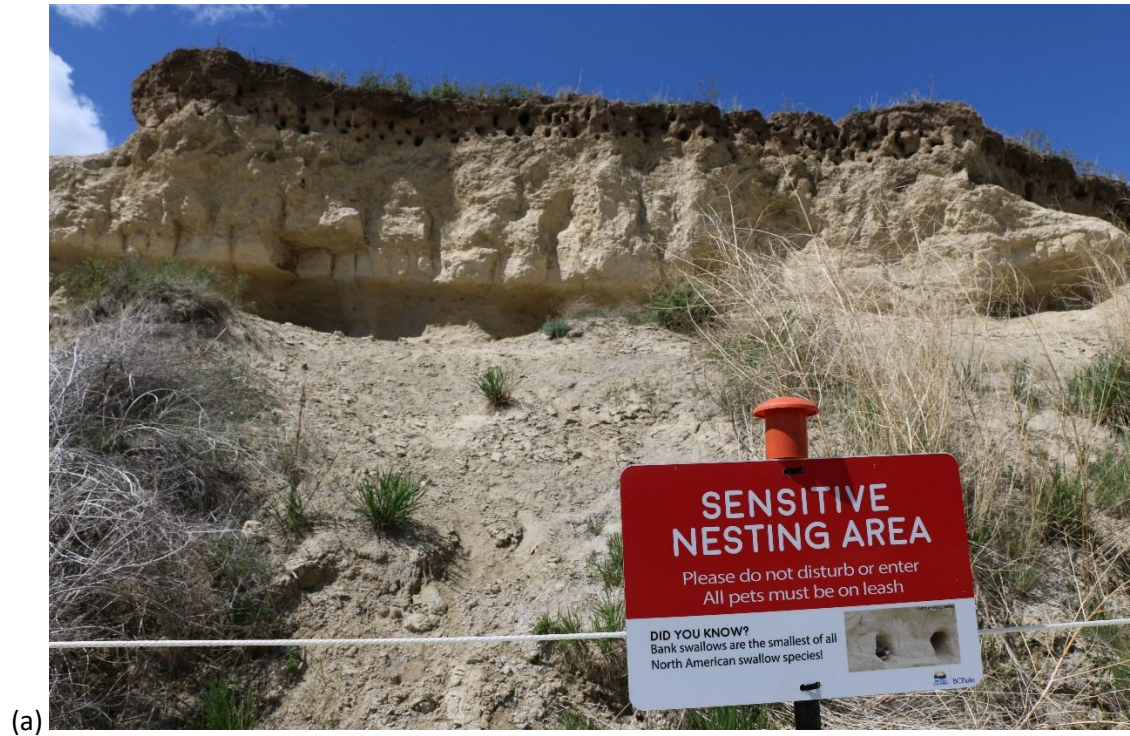
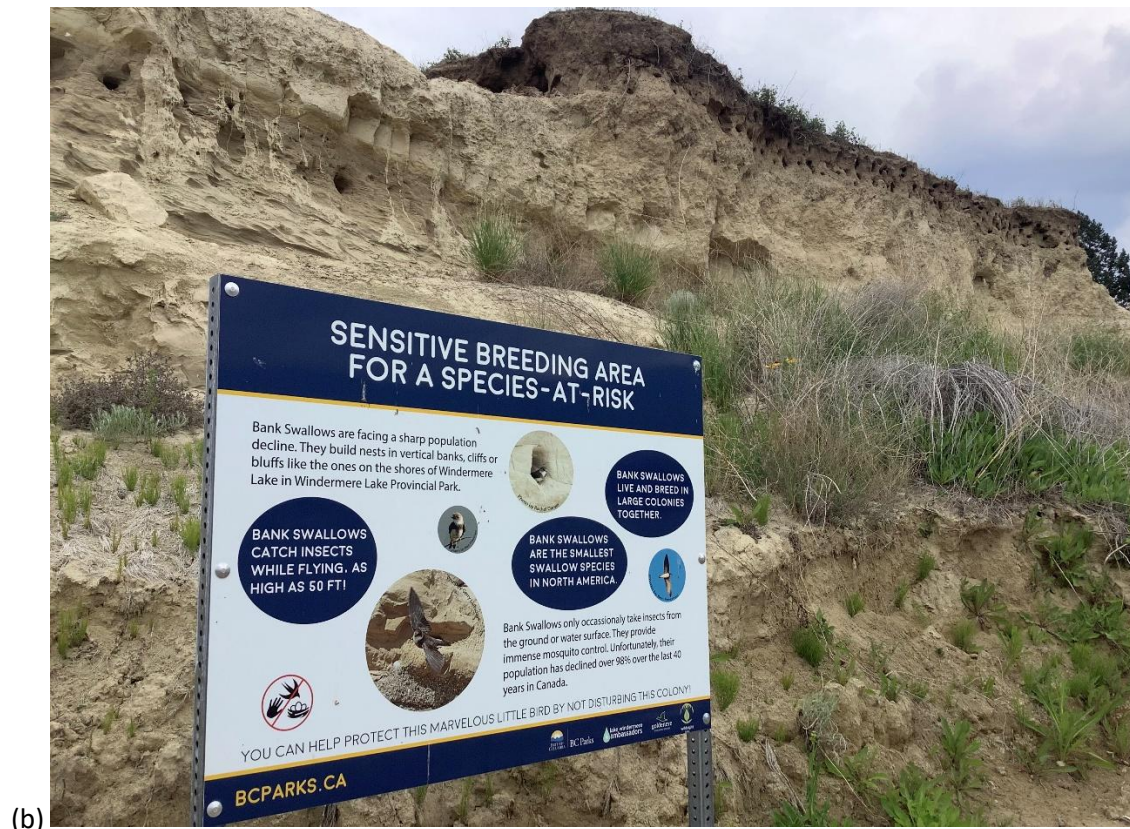
Figure 3. Restoration and access management at Windermere Lake Provincial Park. (a) Barriers and signage; (b) interpretive signage and restored nesting bank.

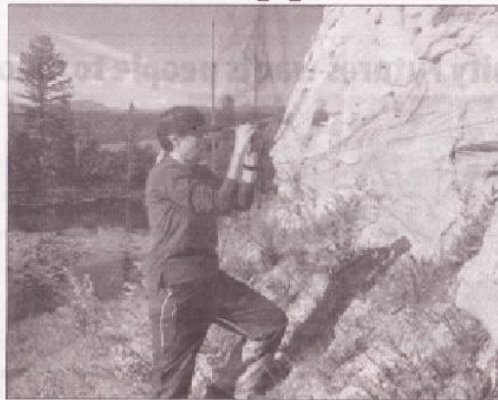
Motus stations in North, Central and South America. ECCC enlisted a Master's student (Sarah Endenburg) from Carleton University (Ottawa, Ontario) who led the charge on the Motus data analysis for Bank Swallows.
